Truro Loops Phase 1 Newham Road

Road Safety Audit – Stage 1 & 2

Document Ref: T/RSA722/R3

Truro Loops, Phase 1

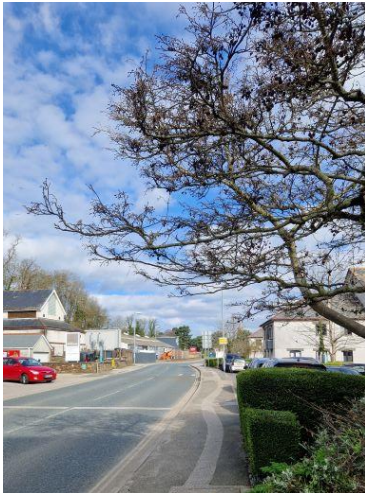
Photo 3

The appears to be a length of shared-use facility outside Morlaix House, where the width reduces to 2.1 metres. As there is vegetation abutting the edge of the existing footway (Photo 3), this would reduce the usable width of the facility for cyclists down to 1.6 metres, as cyclists would not be able to ride along the rear edge of it. Although forward visibility is good, and the narrow width is over a fairly short distance of around 35 metres, this is too narrow for shared-use with pedestrians and could result in a collision between both.

There are low-hanging tree branches over the existing footway, from a tree located outside of 'Bluebird Care' at Morlaix House (Photo 3). Cyclists riding on the proposed shared-use facility following its conversion, may be at risk of a branch getting caught in their cycle helmet and pulling them from their bicycle and causing them to fall, or a branch could strike them in the face, resulting in injury.

Widen the shared-use facility across the frontage of Morlaix House to provide a minimum of 2.5 metres of shared-use width. For example, the proposed carriageway width here is 6.5 metres therefore, the shared-use facility could be widened and additional 300 - 400mm.

Remove low-hanging branches

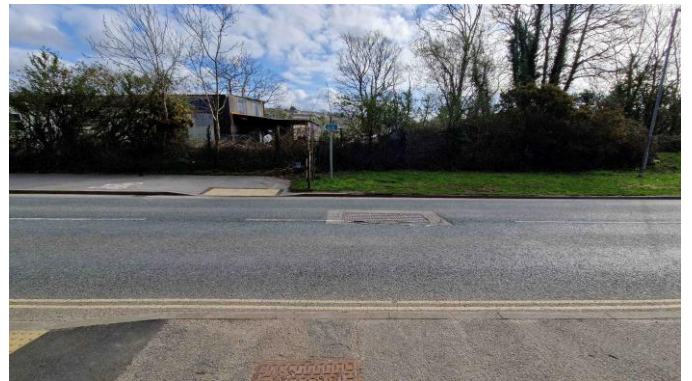
Photo 4

The plans show the dropped kerbs at the Zebra crossing, extending southwards, beyond the end of the eastern shared-use facility, across the grass verge frontage (Photo 4). This is mirrored on the western shared-use facility opposite. This could encourage pedestrians to cross away from the Zebra crossing and from or onto the grass verge, where they could trip, slip or fall on the uneven surface, resulting in injury. The lack of kerb upstand and tactile paving on the western side of the carriageway, could lead to partially-sighted pedestrians inadvertently stepping into the carriageway, where they could be struck by a passing vehicle.

Ensure the dropped kerb provision here only covers the extents of the controlled crossing.

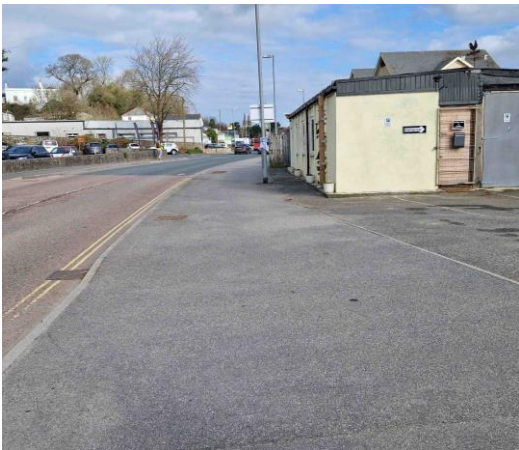
Photo 5

Three sets of cycle stands are proposed along this section, perpendicular to the shared-use facility kerb edge. The stands appear to be shown abutting the rear of the shared-use facility at each location, however, it should be noted that the central set of stands appear to be shown abutting the building edge at 'Fresh Bakes' (Photo 5), though this may not be Public Highway.

In this orientation, the stands would need to be inset from the rear edge to account for the overhang of a bicycle with typically, a 2-metre length required for a parked bicycle. At these locations, the available shared-use footway width would be substantially narrowed, creating a pinch point to below two metres, past the cycle parking areas. There is a risk that cyclists passing by on the shared-use facility could collide with the cycle stands or with bicycles parked at them, and fall resulting in injury, or they could collide with pedestrians at the narrowing.

Position the cycle parking where there is adequate remaining width, taking into consideration the length of a bicycle parked. Alternatively, orientate the cycle stands at the rear of the shared-use facility, parallel to the kerb line.

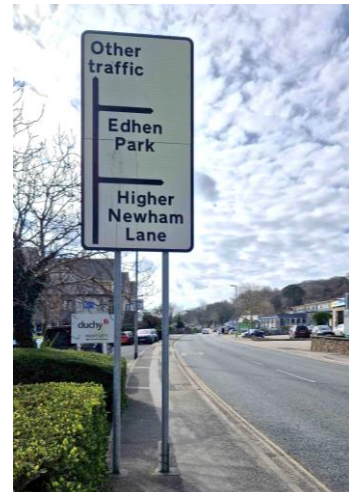
Photo 6

There are a number of signs mounted within the existing footway along the eastern side of Newham Road. The Site Clearance drawing shows the advance direction sign (ADS) (Photo 6), mounted on two posts outside Peat House being removed to store, however no information is provided as to whether it will be reinstated and if so, where or at what height etc. No information is provided to suggest that the 'Unsuitable for long vehicles' sign outside Vivian house (Photo 7), or the 'Higher Newham Lane' (Photo 8) flag sign outside Cornish Mutual, are to be removed. If the ADS is reinstated at the same mounting height and on two posts, it will restrict the shared-use

facility width and be at risk of being struck by passing cyclists who could fall and be injured. If mounted at the same present mounting height, passing cyclists could strike their head on the lower edge of the sign, resulting in head injury. The 'unsuitable for long vehicle' sign and 'Higher Newham Lane' flag sign also present the same mounting height risks to cyclists.

Ensure traffic signs are mounted at the rear of the footway on a single or closely-spaced double post to maximise available width, and are mounted at a minimum of 2400mm above ground level. See also issue 5.3 iii regarding post visibility.
